TECHNICAL BULLETIN
021
January 2018

BACKUP RING PXI VAM 9.850-265.0 (old 000905)

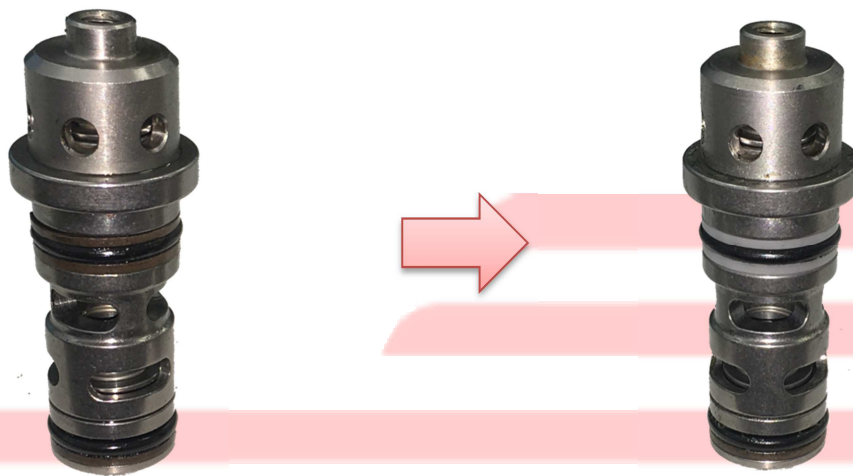
- *Modification of material on 2 backup rings 9.850-265.0 placed in the VAM center cartridge 1.099-704.0 (old 360407) and 1.099-703.0 (old 360406) of the PXI pumps;*
- *This new material improves significantly the durability of the O-ring between the 2 backup rings; visually the new backup ring is white*
- *The new backup ring is interchangeable with the previous one.*

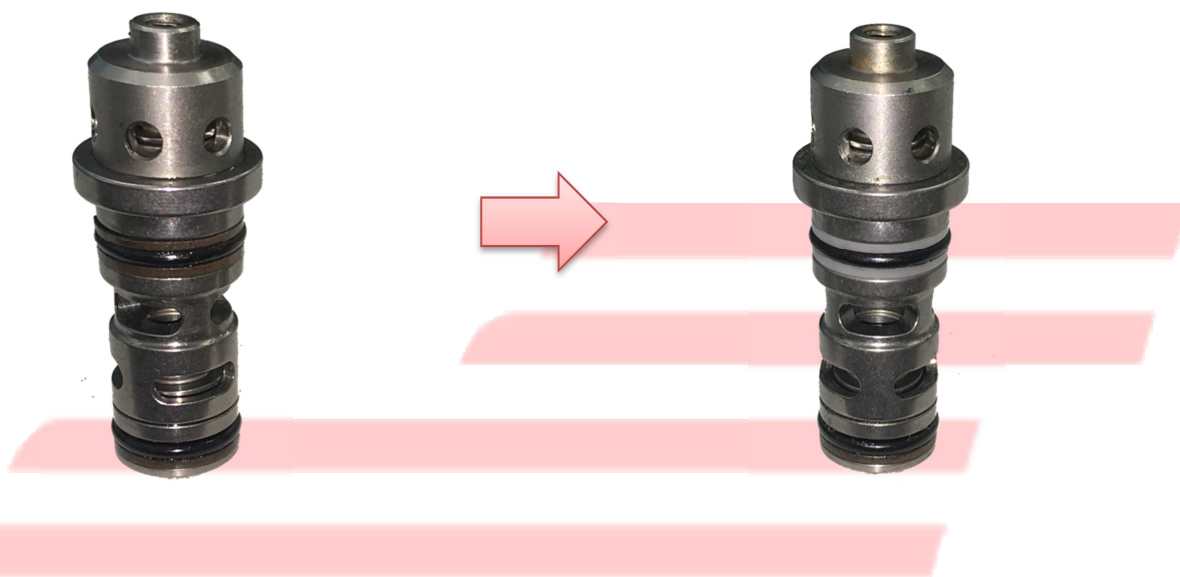
- E' stato cambiato il materiale dei 2 anti estrusore 9.850-265.0 posti in centro alla cartuccia VAM 1.099-704.0 (vecchio 360407) e 1.099-703.0 (vecchio 360406) delle pompa PXI
- Il nuovo materiale migliora sensibilmente la durata dell'anello OR incluso tra i 2 anti estrusori; visivamente il nuovo anti estrusore è di colore bianco
- Il nuovo anti estrusore è intercambiabile con il precedente.
